Client: Cyngor Sir Ddinbych /
Denbighshire County Council

Description of Project

Following a landslide in 2001, the B4391 road to the south of Bala was at risk of being undermined by future failures.

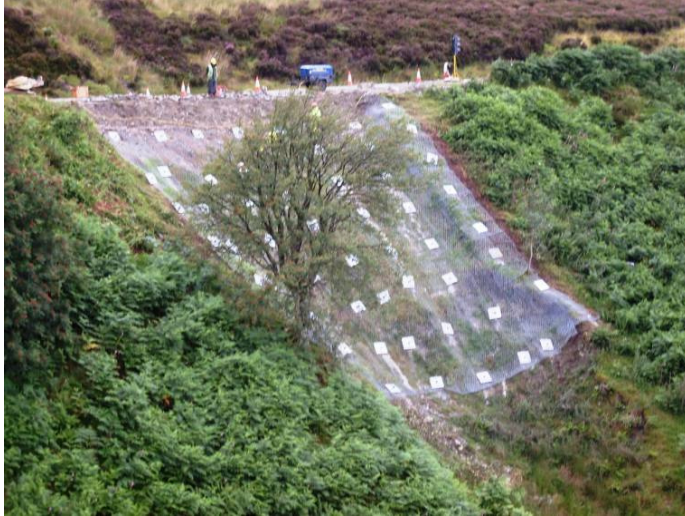
- Reinforcement of failing masonry retaining walls with anchored, masonry clad reinforced concrete buttresses, see photo;
- Formation of a pre-cast drainage channel to collect groundwater which discharged from the upslope heathland;
- Repairs to the existing culvert headwalls

Rotary percussive probing was carried out using rope access techniques to define the rockhead profile along the failure. A soil nailed solution was then designed, with an anchored reinforced concrete beam at the crest of the slope to provide further protection to the carriageway.

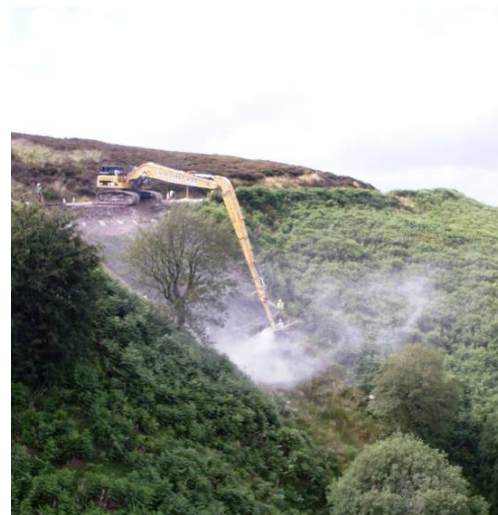
Long reach excavator installing soil nails

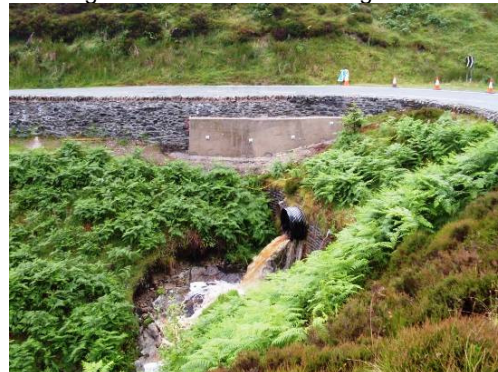
Anchored reinforced concrete buttress (prior to cladding)

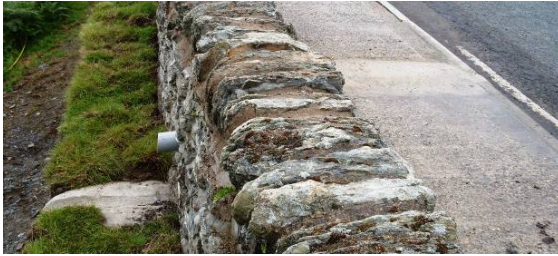
New drainage gully for standing water on bend

- Increase in soil nailed area by 80% to cover recent landslide;
- Increase length of anchored beam at crest of slope by 50% to cover recent landslide;
- Replacement of soft verges with aggregate;
- Formation of an earth safety bund;
- Installation of drainage gullies to remove standing water from carriageway.

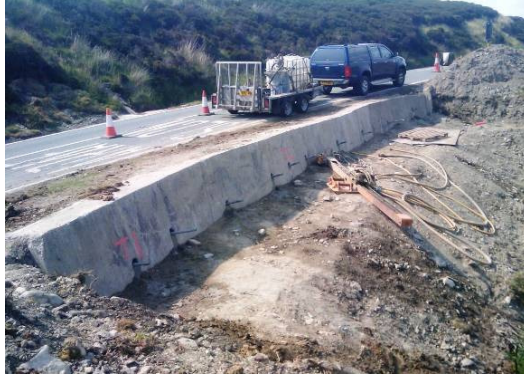
Extended and anchored top beam

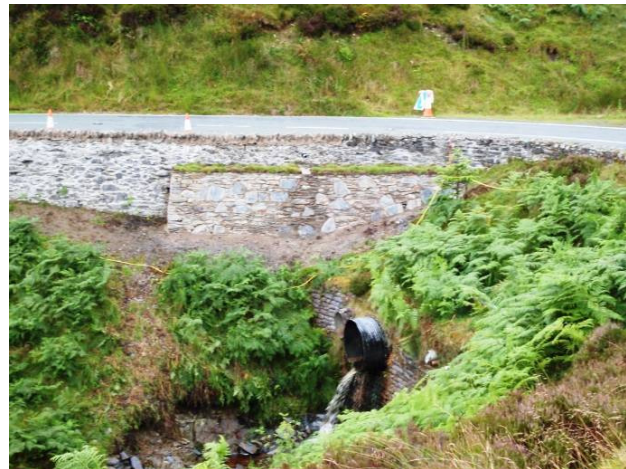
Concrete buttress clad in local stone to tie into existing wall

- The concrete buttresses were clad with local masonry, recovered by the contractor from a disused quarry in the forest downstream of the site;
- Excavated soil from the landslide was used to reinstate the drainage works, ensuring no foreign seeds were introduced to the SSSI;
- Excess arisings from the works were used to landscape a local disused quarry in the ownership of CCW;
- Vegetation on the landslide was left in place to encourage rapid growth that will rapidly camouflage the rock mesh and base plates for the soil nails.
